Date: 11/11/13

Newport Power Solar Annual Inspection

Location: IKEA Emeryville, CA #165

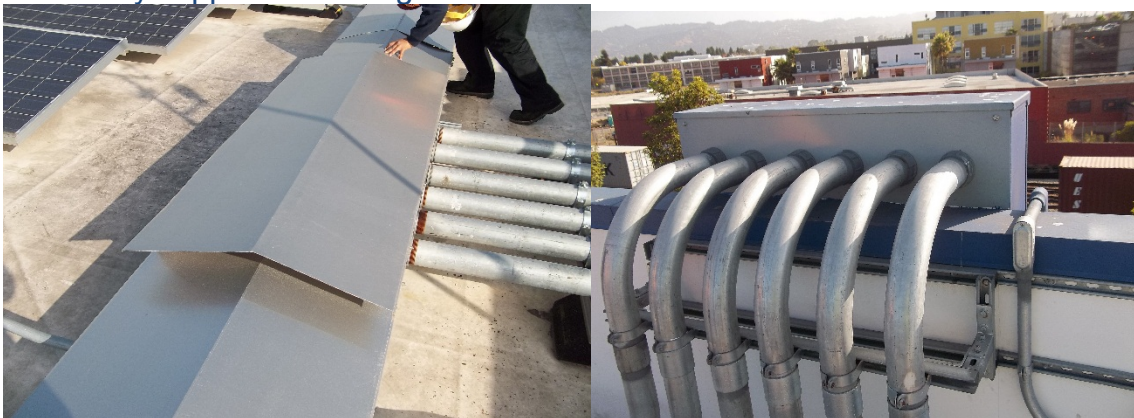
- ✓ **Cable Tray**
- ✓ Check appearance and cover intact
Cable trays appear to be in good condition and in tact.

- ✓ PVC membrane under support members
Membrane under the support members is in good condition, (pliable and in tact).
- ✓ Bonding cable intact at all connections
Bonding cable is in good condition

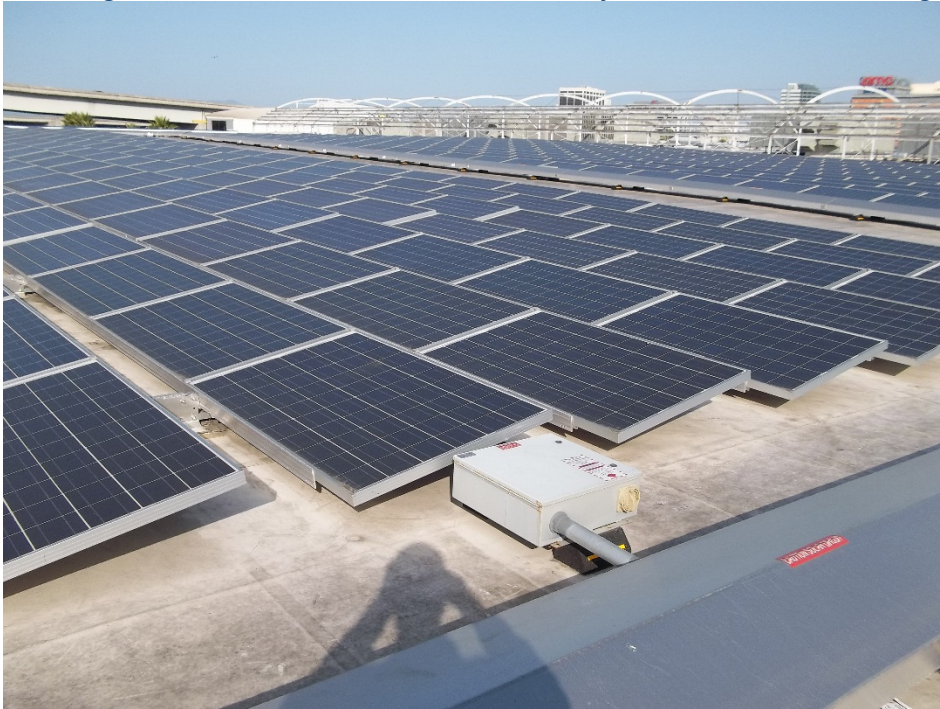
Racking and ballasts' are installed correctly and all hardware is tight and secure.

"Diamond Plate" style PVC membrane is well secured at all ballast pans cable tray, and conduit supports.
